# AN ECOLOGICAL ASSESSMENT OF STAR LAKE MOUNT HOLLY, VERMONT

Prepared for the Mount Holly Conservation Trust

February 2025

**ARROWWOOD ENVIRONMENTAL**

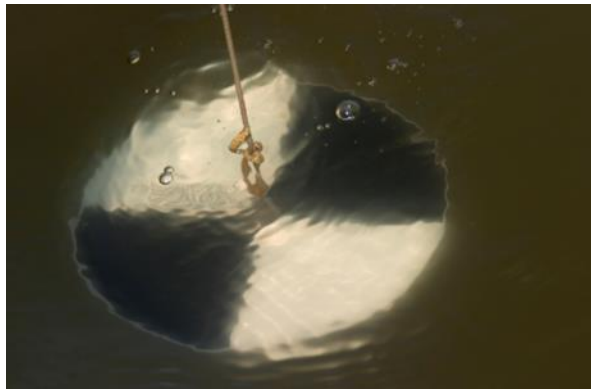
Figure 3. Secchi disk

A final metric used for determining a lake's trophic status is water clarity measured by Secchi transparency depth. As can be seen from the trophic categories in Table 1, oligotrophic lakes have the highest water clarity and hyper/eutrophic lakes have the lowest. Secchi depth readings taken in July of 2024 in Star Lake averaged 1.15 meters. The water clarity of the lake is therefore within the category of eutrophic/hypereutrophic status. This measure of water clarity does not distinguish between the factors that can inhibit water clarity. The low water clarity seen in Star Lake is the result of the shallow nature of the lake. In shallow waterbodies such as this, the lake never stratifies and there is constant mixing of the lake sediments into the water column. This mixing results in low overall water clarity.

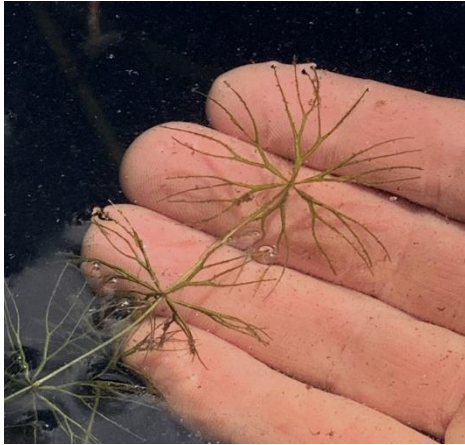
Figure 4. Hornwort

Hornwort (*Ceratophyllum echinatum*) is a submerged aquatic plant that is uncommon to rare in Vermont (S2S3-ranked). This species was found throughout the lake in low abundance, though in small areas it was moderately abundant. Coontail (*C. demersum*) is a closely related very common species that is abundant throughout the lake.

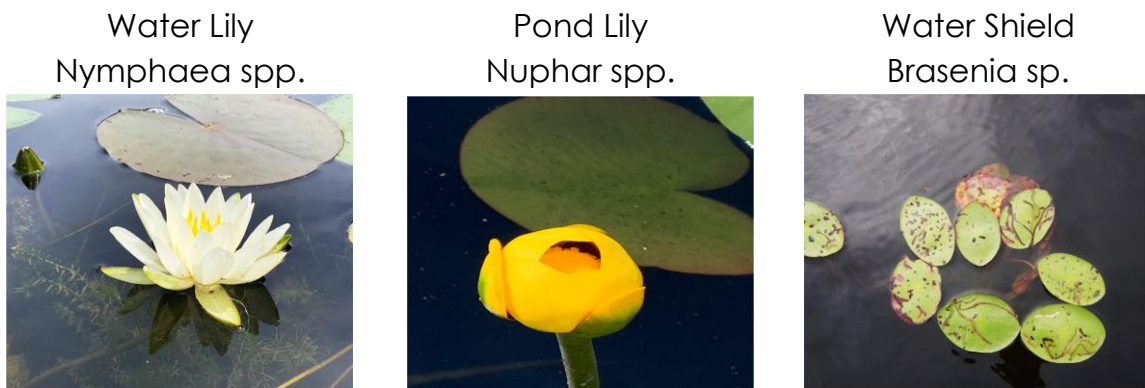
Figure 5. Dominant floating-leaved species in Star Lake

The dominant component of the aquatic vegetation in Star Lake is comprised of floating-leaved plants. Three species make up this floating-leaved layer: white water lily, pond lily, and water shield. Together, these species can form a dense layer covering the water's surface.

The most common of the floating-leaved species is white water lily, which is the dominant plant found throughout the lake. Water shield is also found throughout the lake but is less abundant than water lily. Pond lily, with its more rounded leaf bases and yellow flowers, is most abundant on the eastern shore, though can be found in scattered locations throughout the lake.

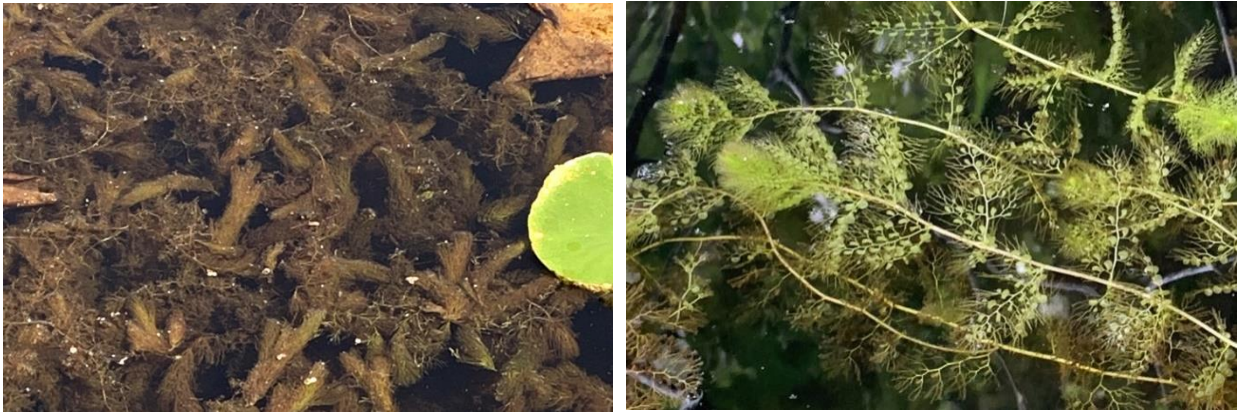
Figure 6. Coontail (left) and bladderwort (right)

The most common submerged aquatic species in the lake are coontail, common bladderwort and curly pondweed. The first two species comprise most of the submerged aquatic flora in the lake (see below for discussion of curly

pondweed). The overall diversity of aquatic species in the lake is quite low.

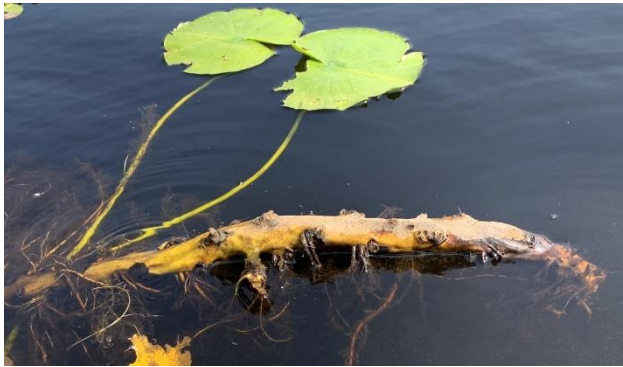
Figure 7. Rhizome of water lily

Though sexual reproduction is important for the survival (and continued evolution) of the floating-leaved species, most of the spread of water lily occurs via asexual reproduction. Growing beneath the sediment at the base of these plants is a large underground stem called a rhizome. This rhizome grows horizontally through the sediment and readily sprouts new stems. In order to support this structure, significant amounts of energy in the form of starch need to be allocated to the rhizomes. The rhizomes are the reason that floating-leaved species are able to spread so rapidly in areas that have suitable habitat like Star Lake. Removal of the leaves and stems does little in terms of overall plant control since new leaves can readily sprout from the rhizome.

This large starchy organ has not gone unnoticed by wildlife; it is commonly eaten by beavers and is the main source of food for muskrats. When moose wade into the shallows of a pond, they are doing so to feed on rhizomes, which can constitute the main source of their summer diet. In many cases, beavers and

muskrat will dislodge the rhizomes while feeding; which then float to the surface and have the appearance of small logs or baseball bats.

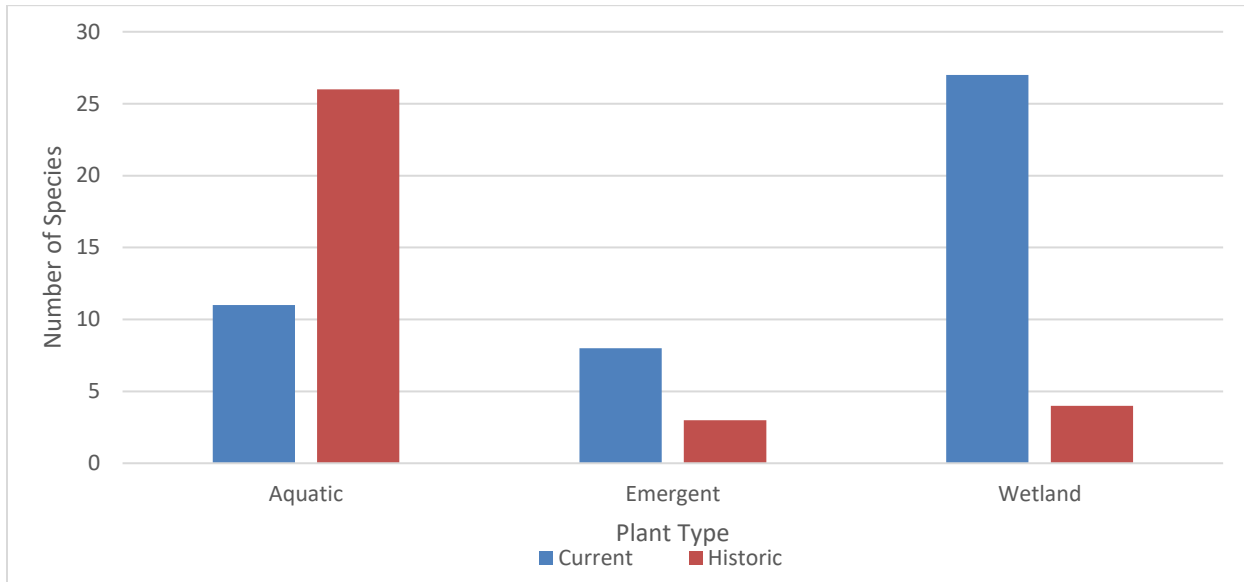
Figure 9. Change in Plant Type

Each species documented historically was also categorized by plant type as described above. This categorization allows a more detailed analysis of plant diversity in the lake. Figure 9 illustrates that the number of aquatic plants in the lake has decreased, while the number of wetland plants has increased substantially.

The increase in the number of wetland plants could be the result of a difference in survey methodology, a change in the plants present, or a combination of the two. While wetland-type plants are included in the Vermont Lakes and Ponds Program plant lists, the focus of the inventories were typically on aquatic plants, and it is unknown how much attention was on inventorying the wetland plants growing on the margin of the lake. The increase in wetland plants shown in Figure 9 could also be a result of more wetland-type habitats present on the shores of the lake. This occurs as the lake becomes shallower and the

near-shore areas that represent the transition between the aquatic and wetland habitats becomes wider. In these cases, wetland-type plants become more dominant along with emergent-type plants.

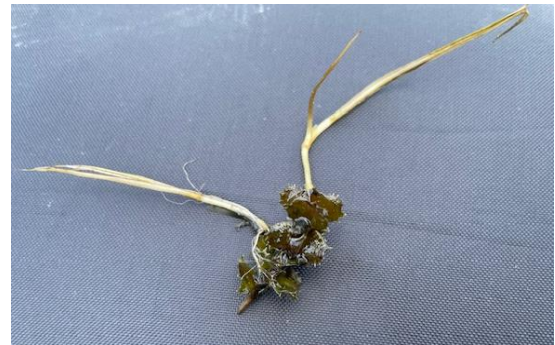
Figure 10. Sprouting turion of curly pondweed

Curly pondweed is native to Eurasia and has been well-established in the region since the early 1900s. It reaches its greatest abundance early in the growing season (July) and by late summer may be mostly senesced. While it can reproduce by sexual reproduction via seed, the most common way that it spreads is via fragmentation and the production of turions.

Turions are winter buds that are formed in the summer at the tips of the plants, fall off the plant and settle in the sediment. These turions then sprout and grow a new plant in late winter or early spring.

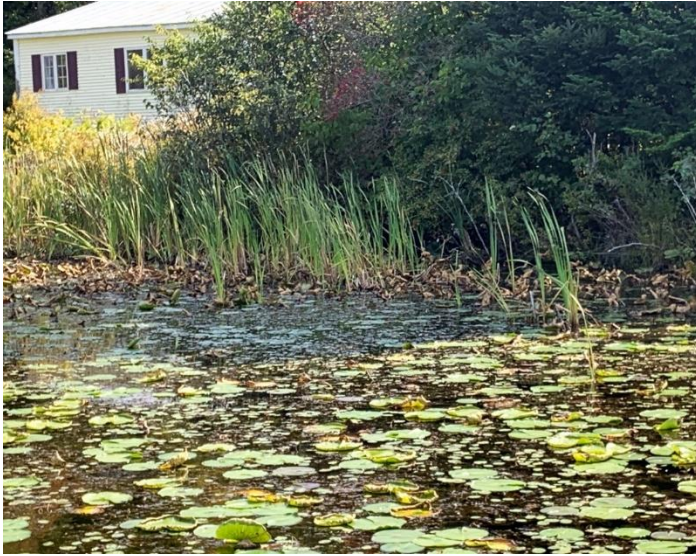
Figure 11. *Cattails colonizing shallow areas*

Aquatic systems are complex systems influenced by different factors such as hydrologic inputs, water residence time, nature of outlets, size of the basin, depth, bathymetric shape of the basin, sediment type and vegetation. In many cases, the classic succession from aquatic to terrestrial ecosystem does not occur without dramatic changes to the physical structure of the lake. However, terrestrialization can occur in shallow ponds with abundant aquatic vegetation and in ponds with high rates of sediment accumulation.

In Star Lake, this positive feedback loop driven by the abundant aquatic vegetation and deep organic sediments has created conditions favorable for terrestrialization. This process can be seen spatially in areas of the lake where cattails have colonized the margins of the lake and are expanding out away from the shore.
